Seismic Strengthening of Circular Bridge Pier Models with Fiber Composites

by H. Saadatmanesh, M. R. Ehsani, and Limin Jin

An experimental investigation was conducted to study the seismic behavior of reinforced concrete columns strengthened with fiber reinforced plastic (FRP) composite straps. Five concrete column-footing assemblages were constructed with a 1/5-dimensional scale factor. The unidirectional glass fabric straps were impregnated with polyester resin and wrapped around the potential plastic hinge zone of the columns. An epoxy layer was applied to the straps while wrapping for interlaminar bond. All specimens were tested under inelastic reversal loading while simultaneously subjected to a constant axial load. Test results show that seismic resistance of retrofit concrete columns improves significantly as a result of the confining action of the FRP composite straps. The straps are highly effective in confining the core concrete and preventing the longitudinal reinforcement bars from buckling under cyclic loading.

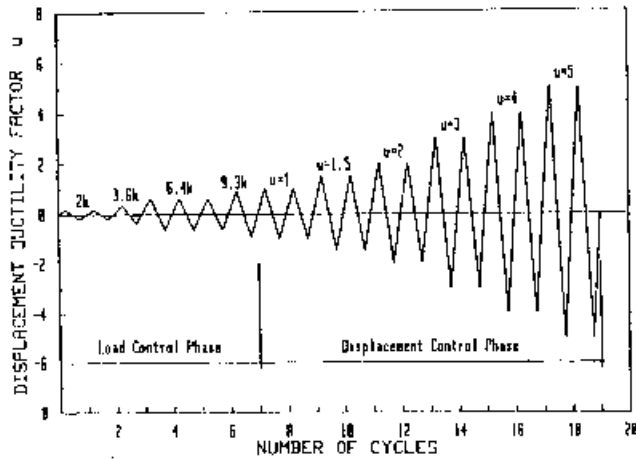
Fig. 6 Loading sequence

The effect of an earthquake on the column specimen was simulated by reversed cyclic loading. The hydraulic actuator in the test setup was used to displace the top of the column to achieve a predetermined load level or displacement. Then, the loading direction was reversed to achieve the same load or displacement level in the opposite direction. The load and displacement input history was broken into two phases. At the initial stage, the test was in a load control mode. On yielding of the longitudinal reinforcing bars, a displacement control mode of loading was utilized; Fig. 6 shows the loading sequence. The letter "u" in this figure indicates the

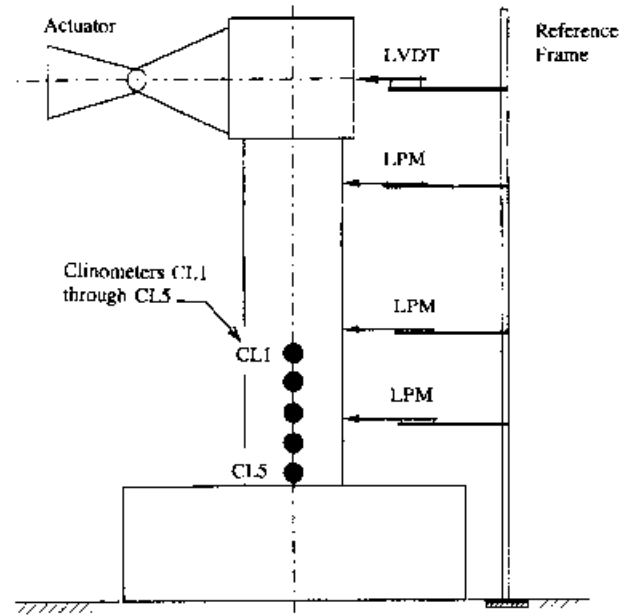
Fig. 7—Inclinometer and transducer arrangement

Ten electrical inclinometers were distributed at 127 mm (5 in.) spacing over both opposite faces of the column within the plastic hinge region from the top of the footing up to a height of 635 mm (25 in.), as shown in Fig. 7. Data from these inclinometers were used to measure the plastic hinge rotations at critical sections of the column and to plot the moment-curvature relationship of these sections. Along the height of the column, four displacement transducers were used to monitor the column deflection, as shown in Fig. 7.

Ten electrical inclinometers were mounted along the center line of each column on opposite faces (east and west), as shown in Fig. 7. The plastic rotation of specific sections of the column was then obtained from the readings of each inclinometer. An average curvature at the section was calculated from

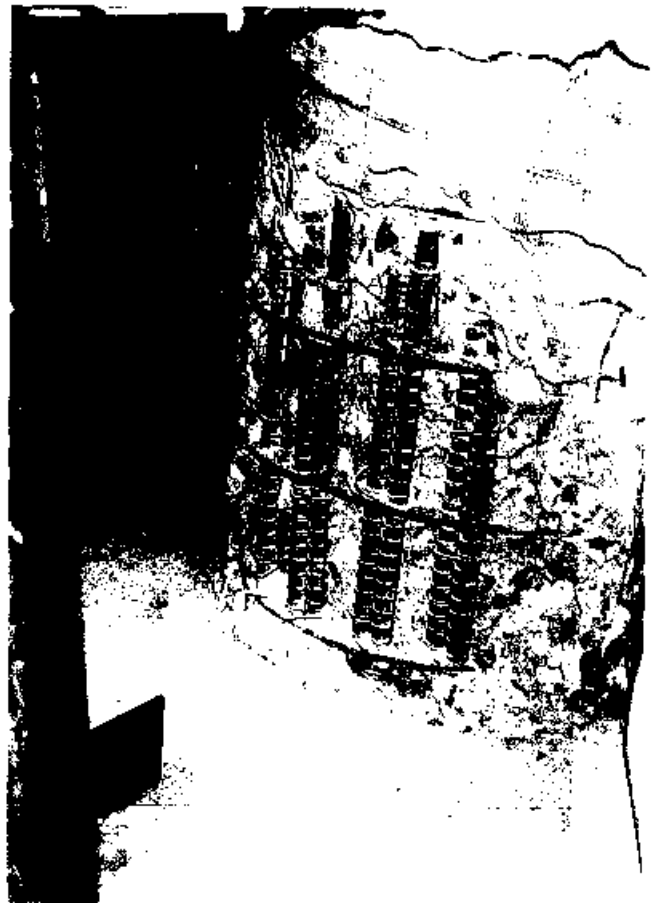
Fig. 22—Bond failure of Column C-1

within the plastic hinge region. The primary change of the behavior in Column C-1 occurred in the plastic hinge region at the displacement ductility level of $u = 1.5$. At this stage of the test, the cover concrete spalled and the longitudinal reinforcement bars started to debond in the lap-spliced region, as shown in Fig. 22. Column C-4 with continuous reinforcement started to fail at a displacement ductility level of $u = 4$. At this point, the longitudinal reinforcement started to buckle and the lateral load-carrying capacity reduced rapidly until complete failure of the column, as shown in Fig. 23.
