# Managing for Future Risks of Fire, Post-Fire Flooding and Extreme Precipitation

# Southern Nevada Water Authority

# Case Study New Mexico - Watershed Responses following Major Wildfires of 2011 thru 2014 in the Albuquerque District AOR

Stephen K. Scissons, PE, CFM  
USACE – ABQ District

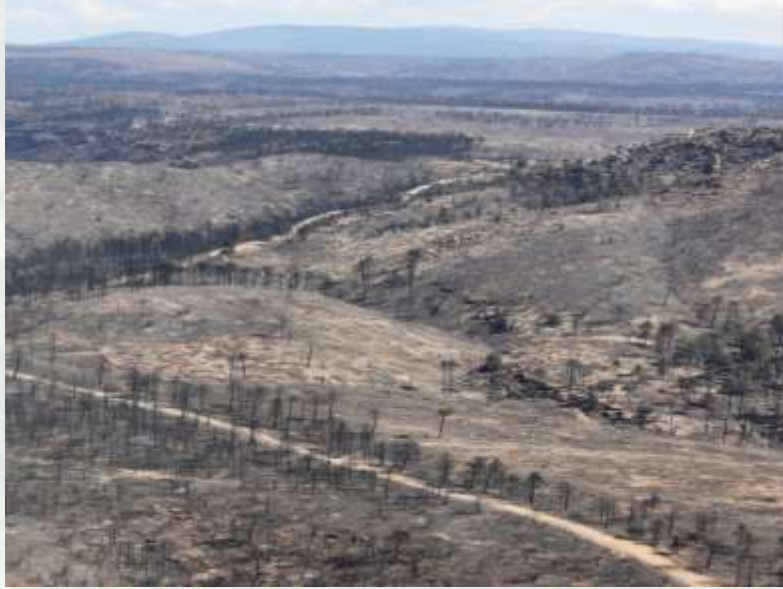
Post-Las Conchas Fire  
Bland Canyon  
August 7, 2011

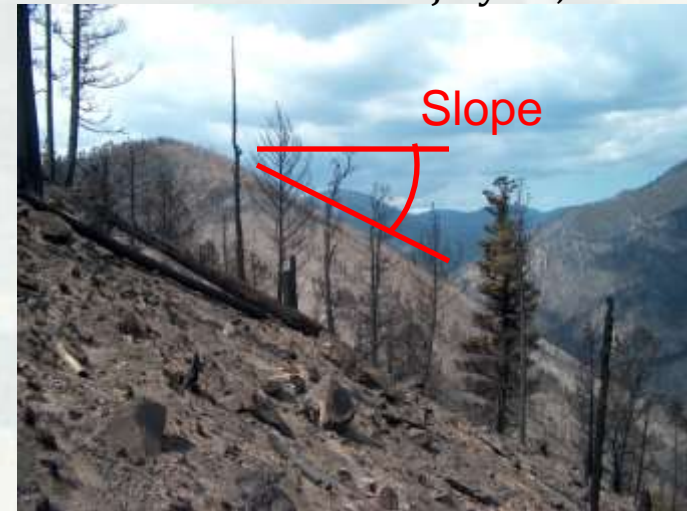
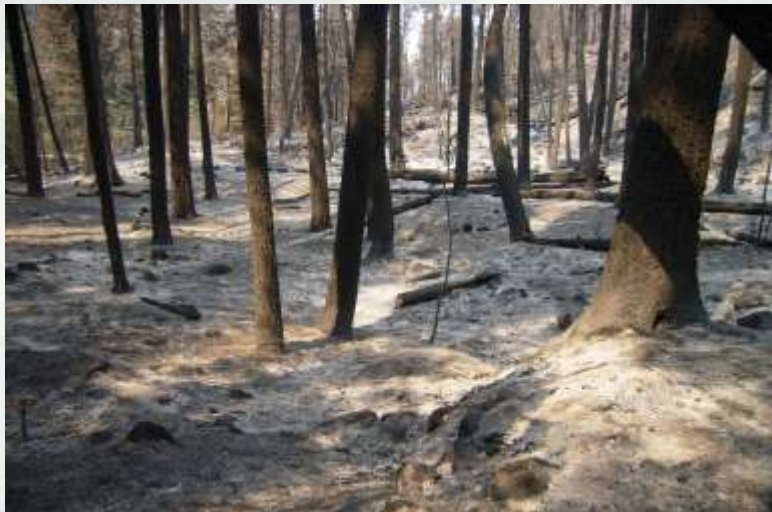
Post-Las Conchas Fire  
Santa Clara Canyon  
July 14, 2011

Post-Las Conchas Fire  
Santa Clara Canyon  
July 8, 2011

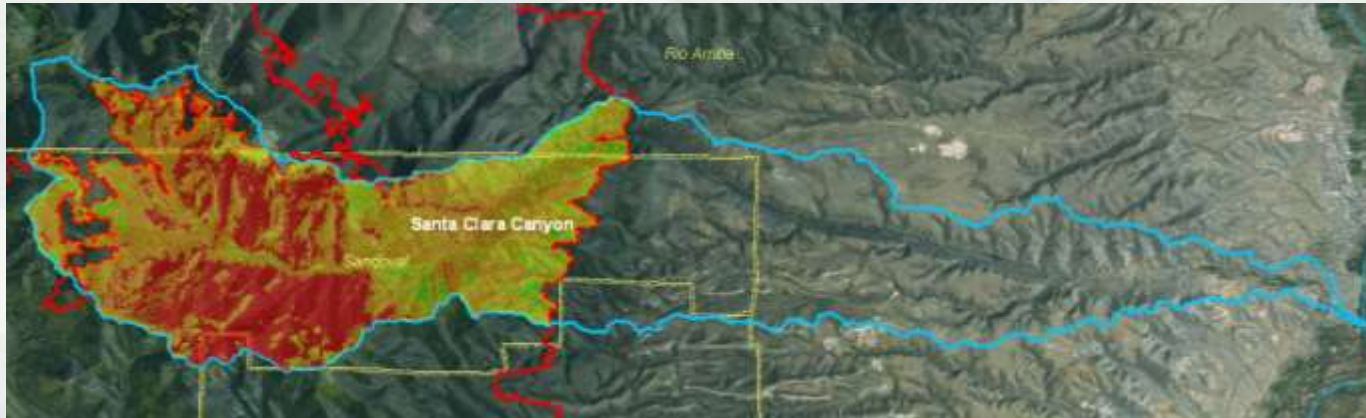
### Burn Severity Breakdown for two select watersheds

#### Santa Clara Canyon: 49 mi<sup>2</sup>

| Moderate: | 47% |
| High: | 30% |

#### Peralta Canyon: 48 mi<sup>2</sup>

| Moderate: | 42% |
| High: | 15% |

- **Hydrologic Modeling Context**
  - ▶ HEC-HMS used to model runoff
  - ▶ Vegetation
  - ▶ Organic layer
  - ▶ Hydrophobic soil layers
  - ▶ Altered runoff characteristics
  - ▶ Using burn severity mapping:
    - Severe – infiltration set to zero
    - Moderate – infiltration reduced by 50%
    - Low – infiltration reduced by 20%

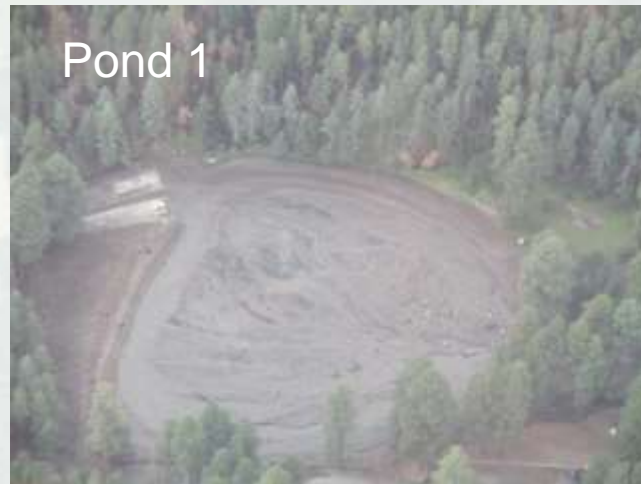
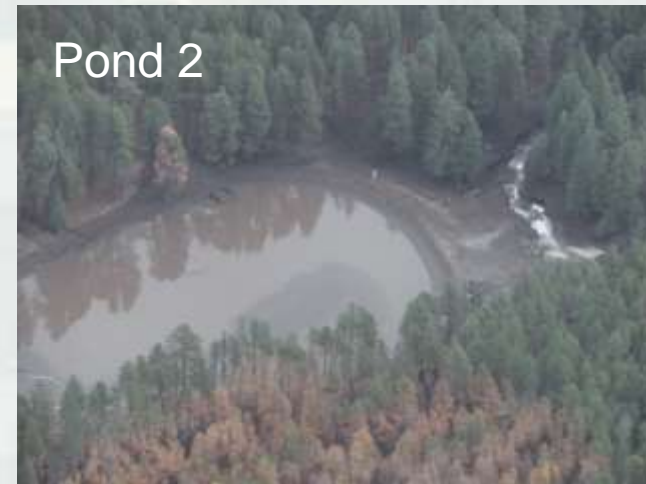
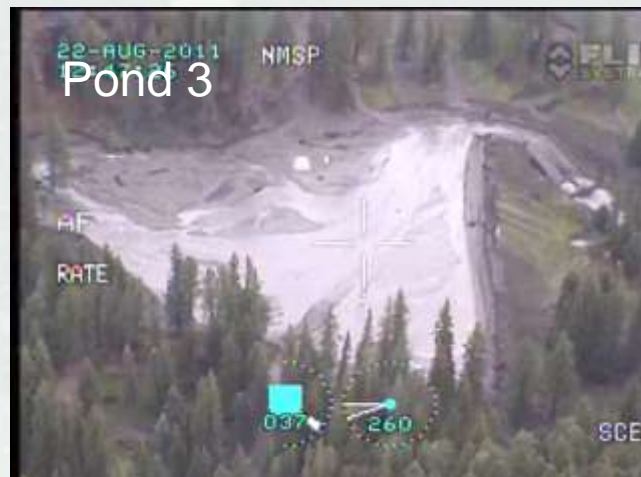
## Santa Clara Canyon August 21, 2011

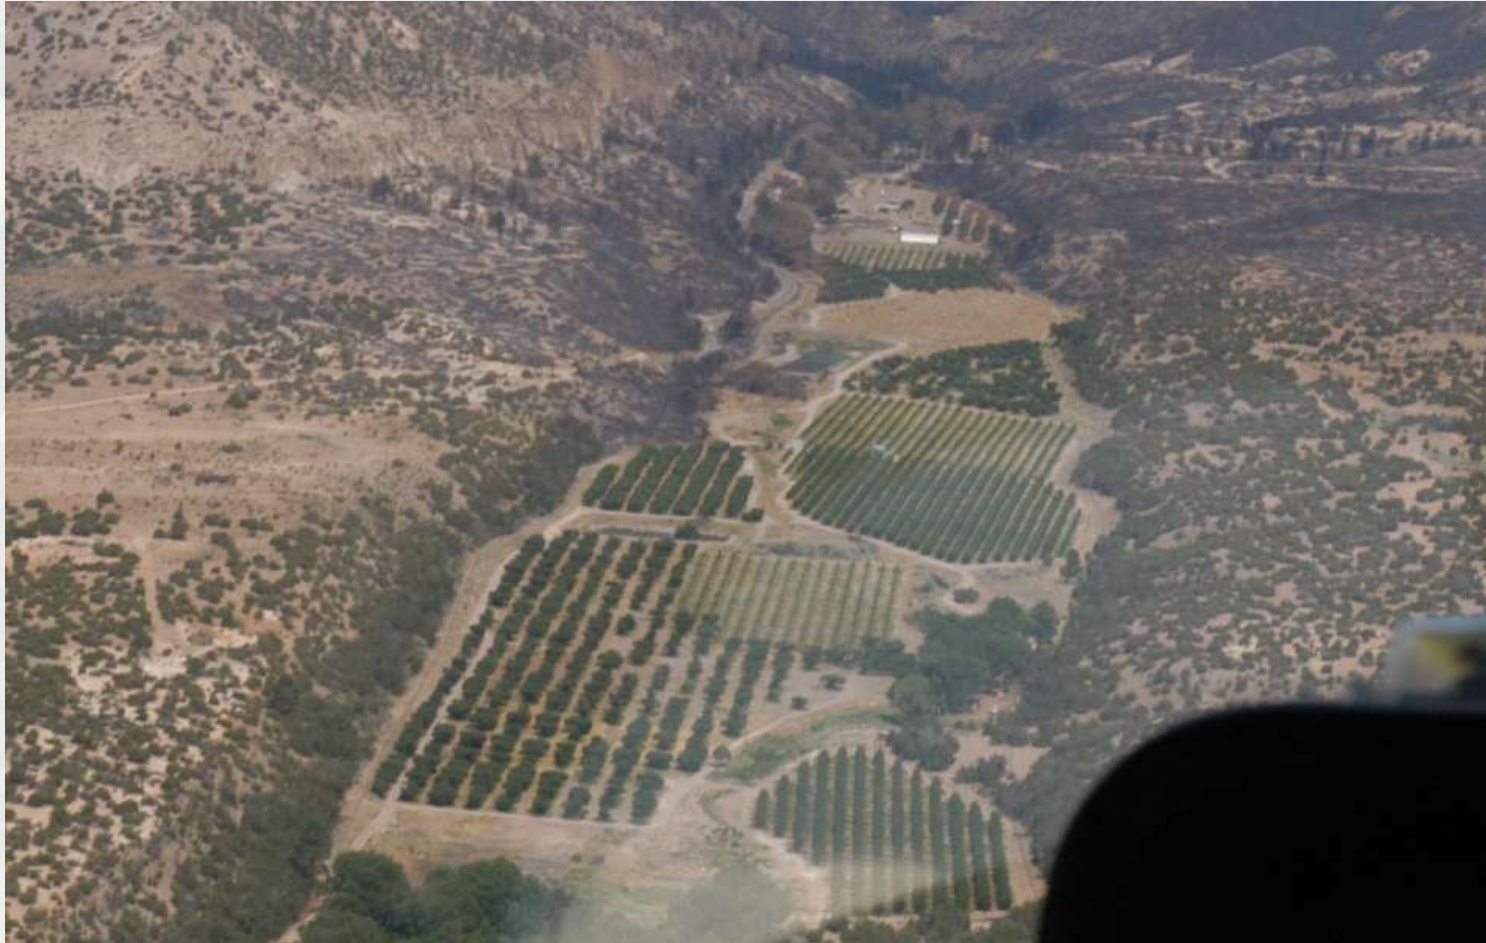
# Cochiti Canyon / Dixon Orchard

Post-Fire/Pre-Flood Photo Taken 07 Aug 11

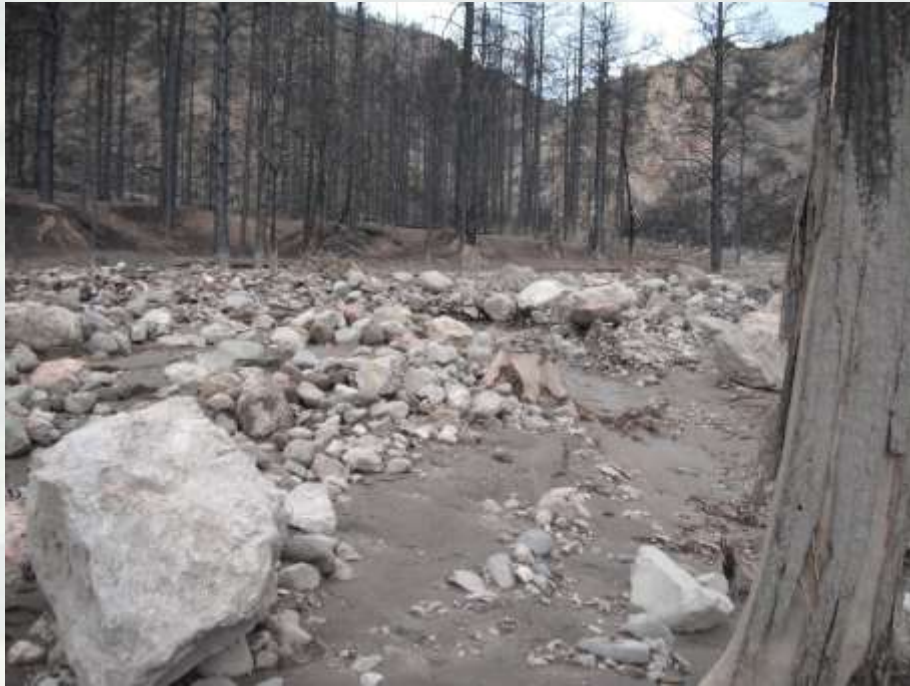
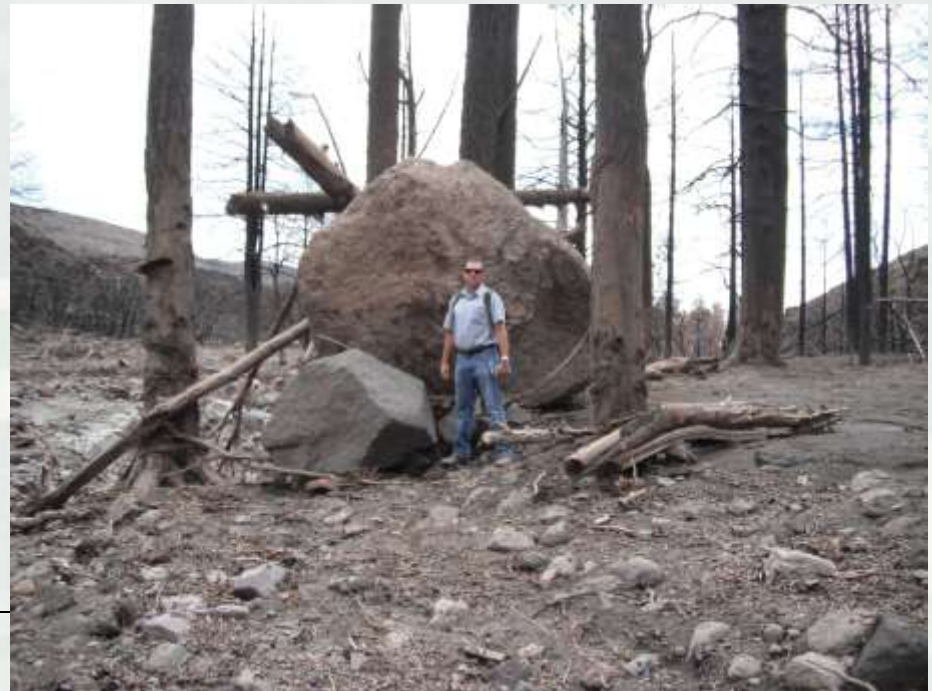
**Cochiti Canyon  
Post-Flood  
August 25, 2011**

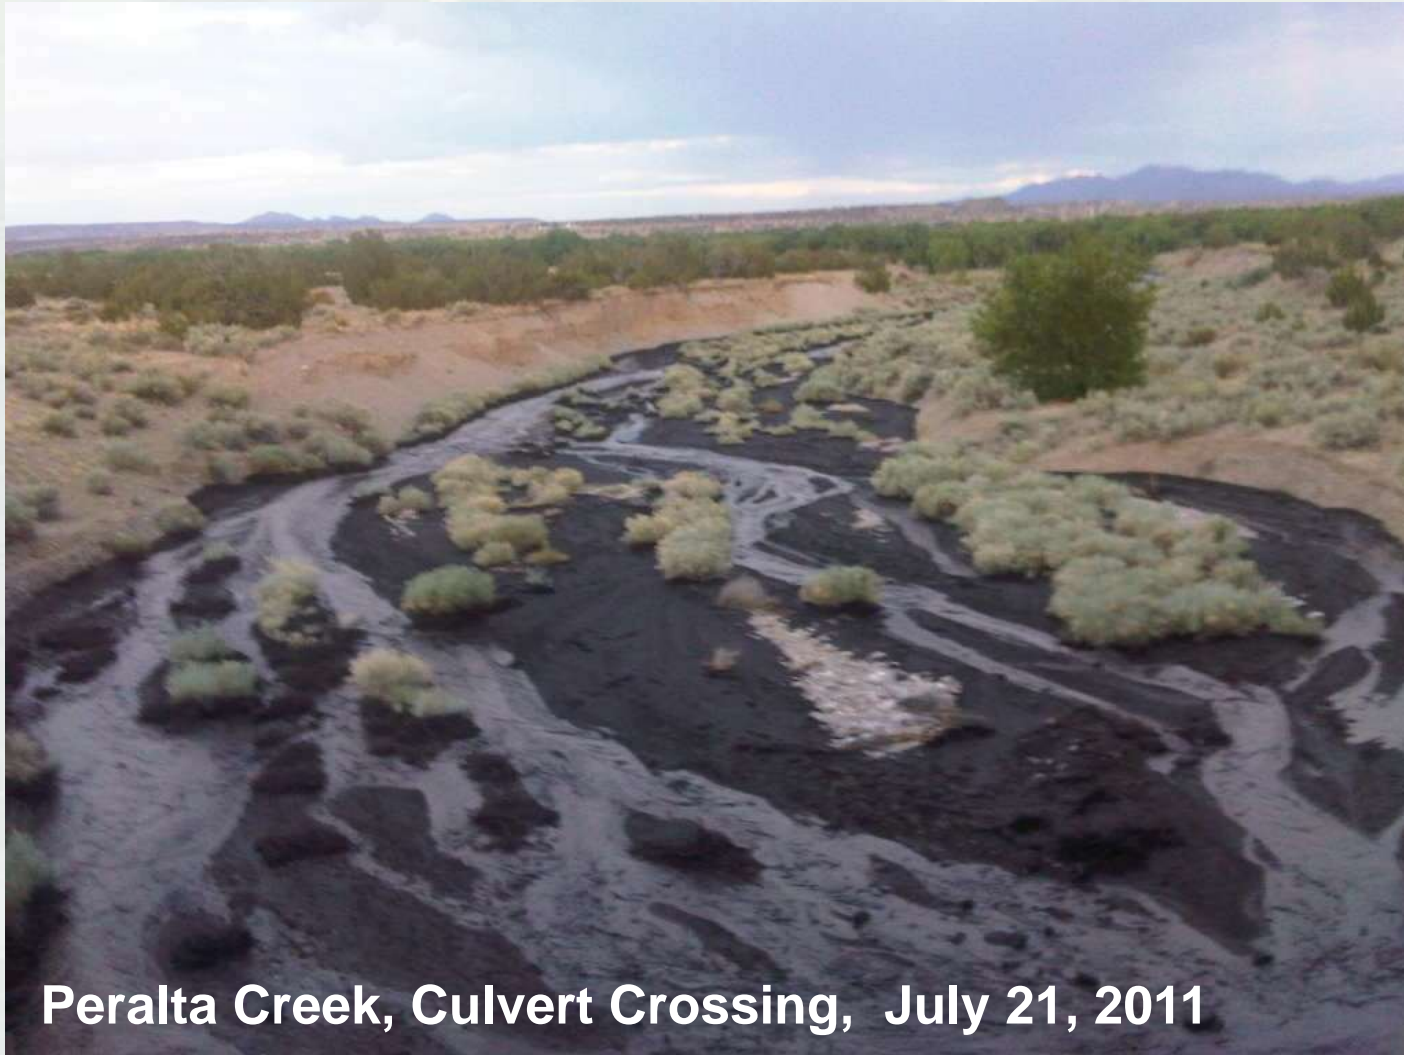
Peralta Creek, Culvert Crossing, July 21, 2011

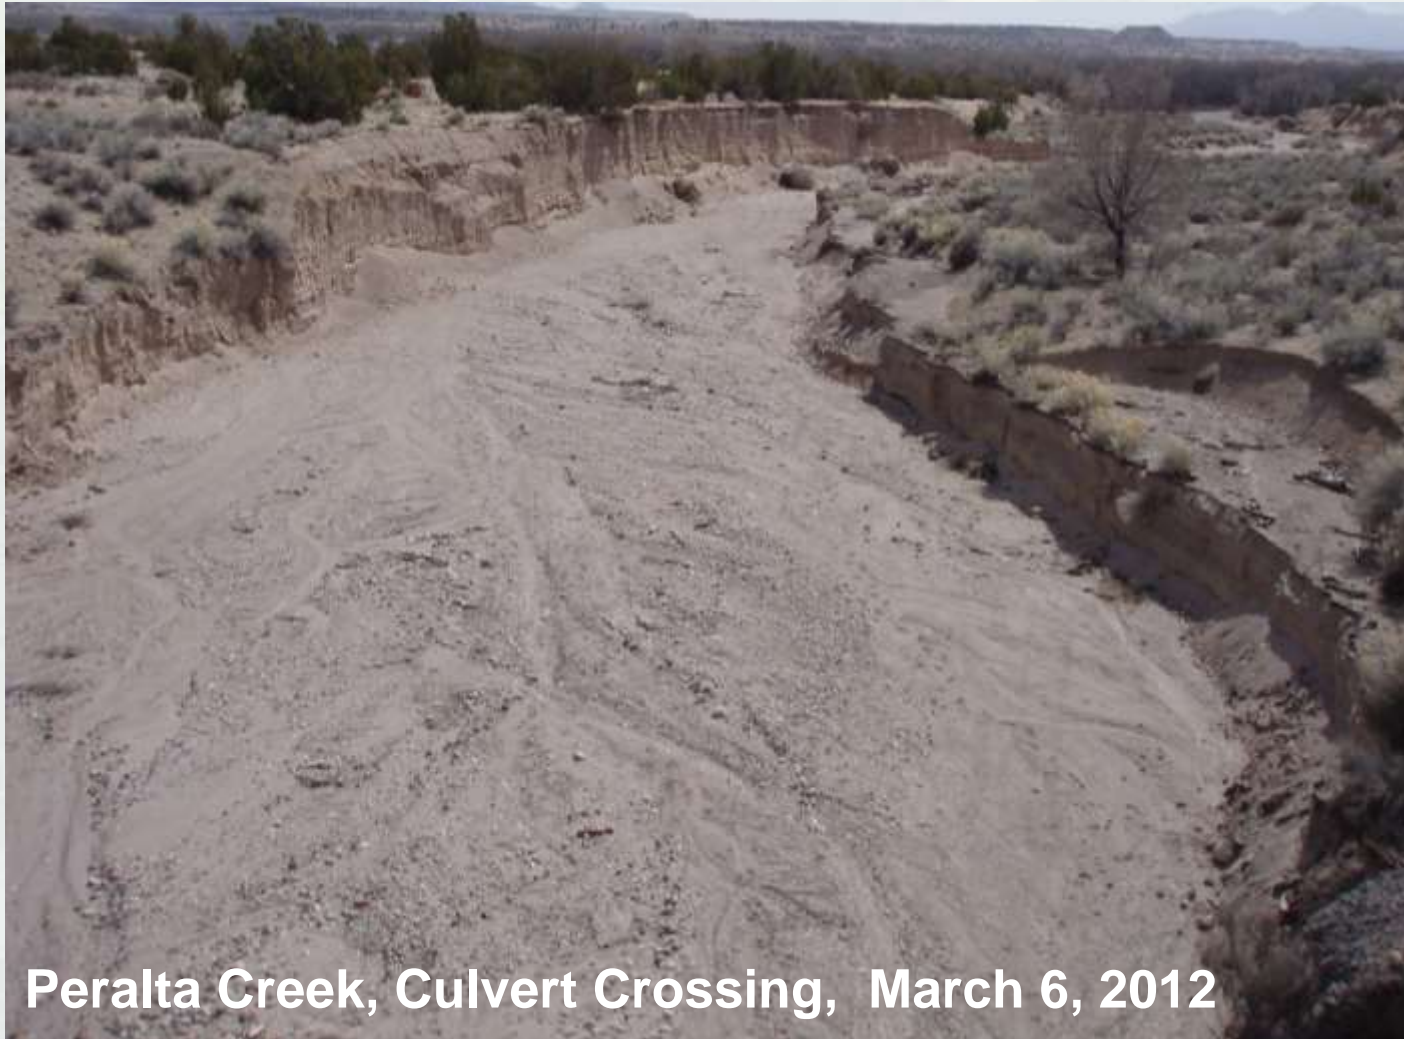
Peralta Creek, Culvert Crossing, March 6, 2012

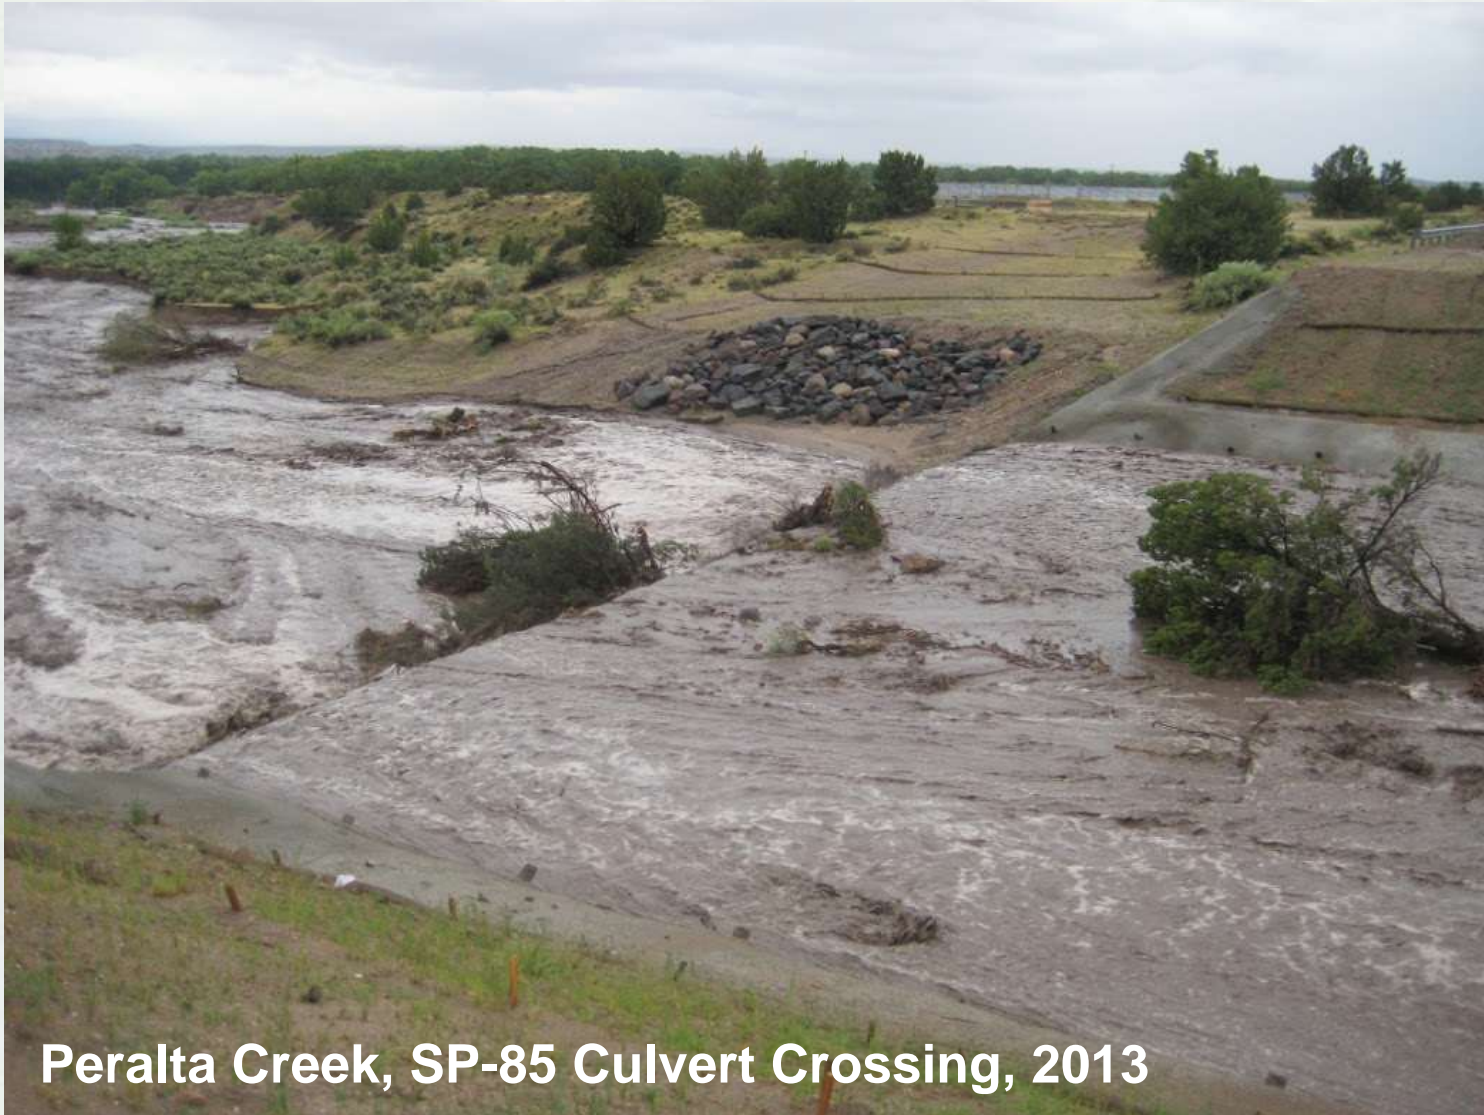
Peralta Creek, SP-85 Culvert Crossing, 2013

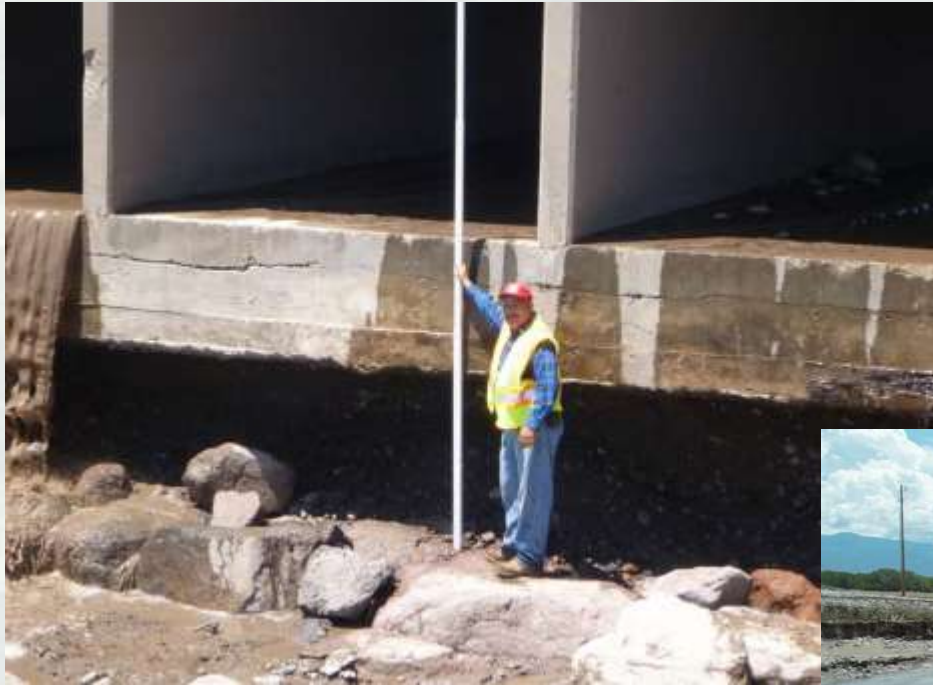
**Culvert Crossing Kee St. –  
Santa Clara Creek  
July 26, 2013**

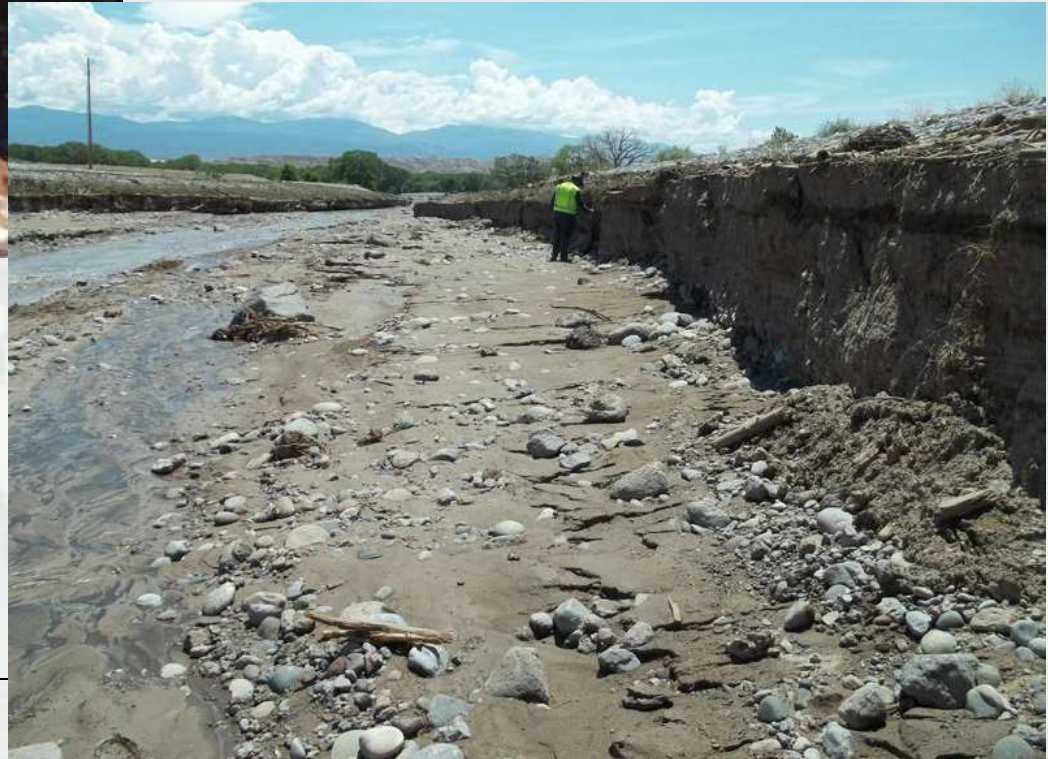
**Village Reach -  
Santa Clara Creek  
July 26, 2013**

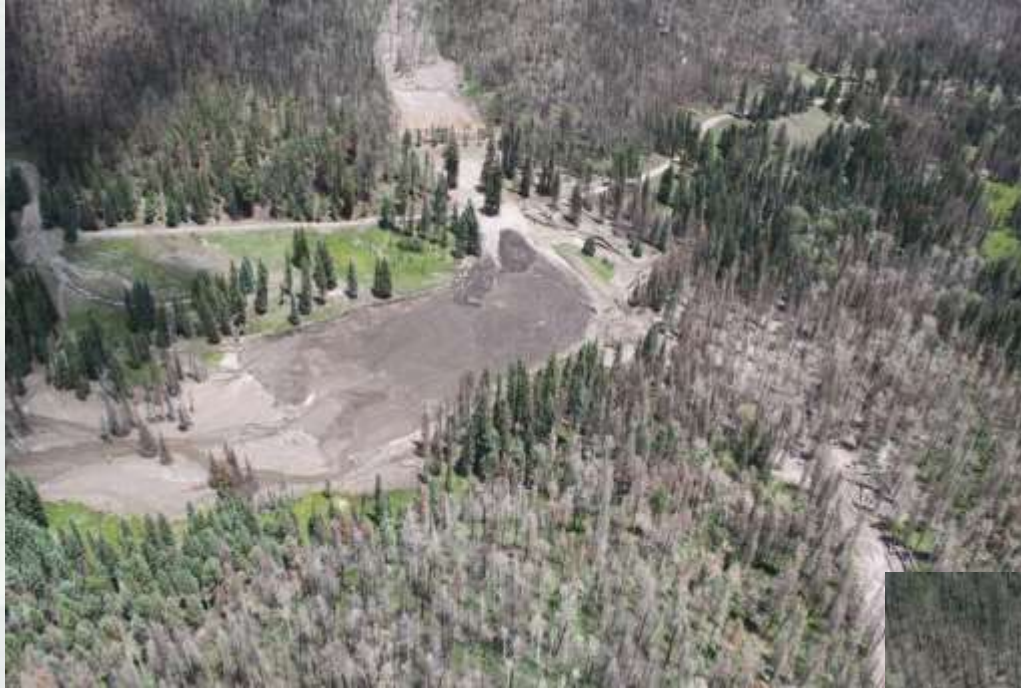
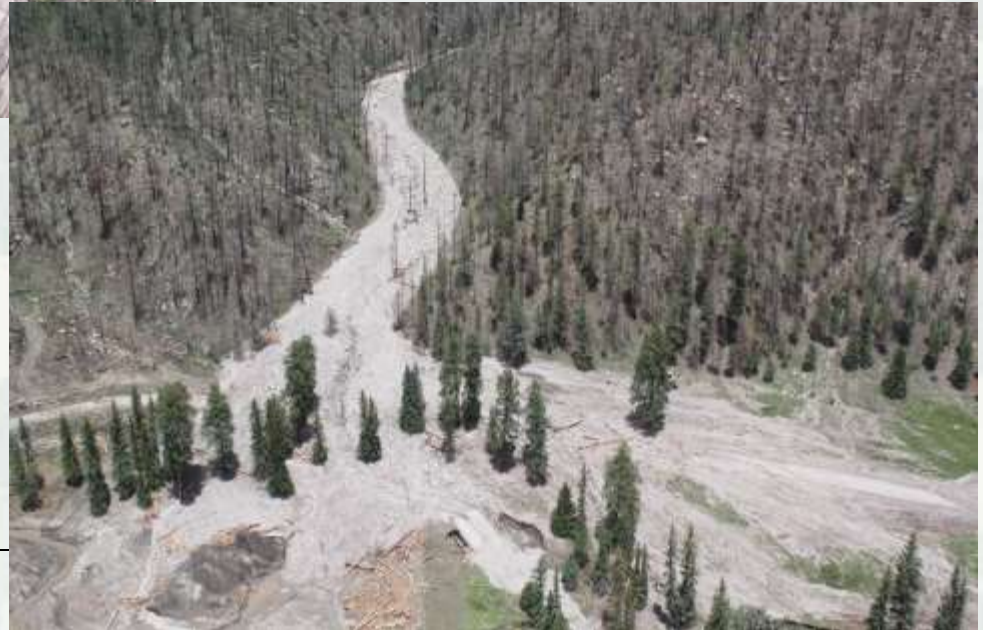
**Pond 4 – Santa Clara Canyon  
July 26, 2013**

**Pond 3 – Santa Clara Canyon  
July 26, 2013**

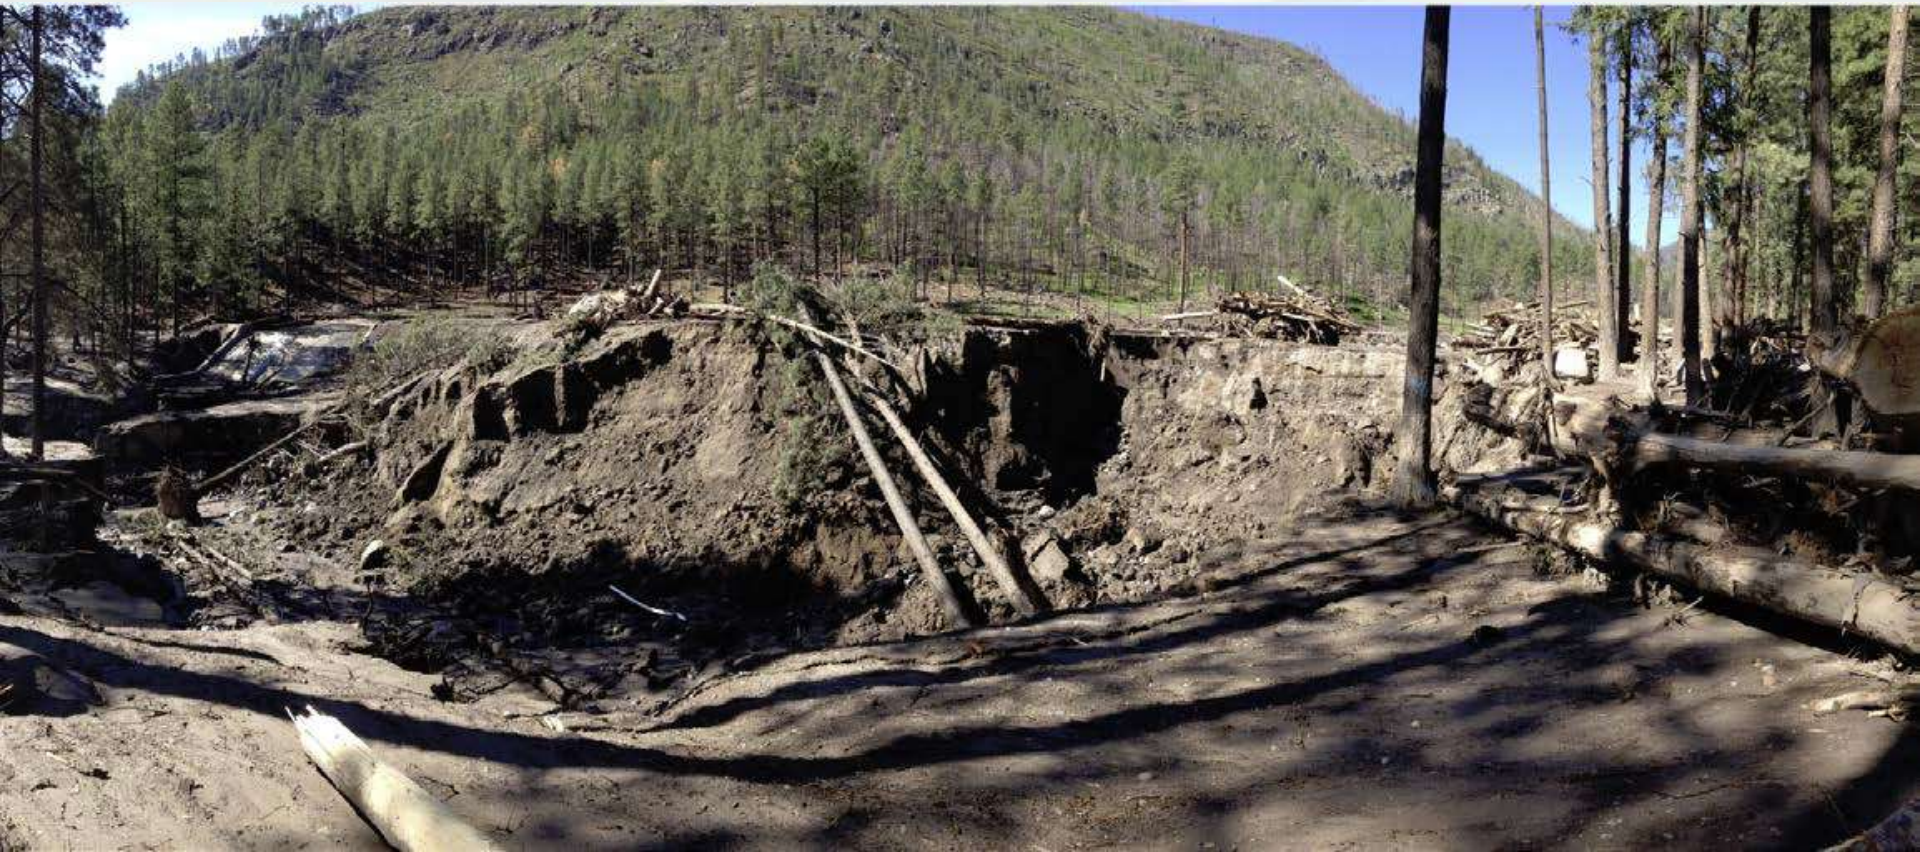
**Pond 1 – Santa Clara Canyon – July 26 2013**

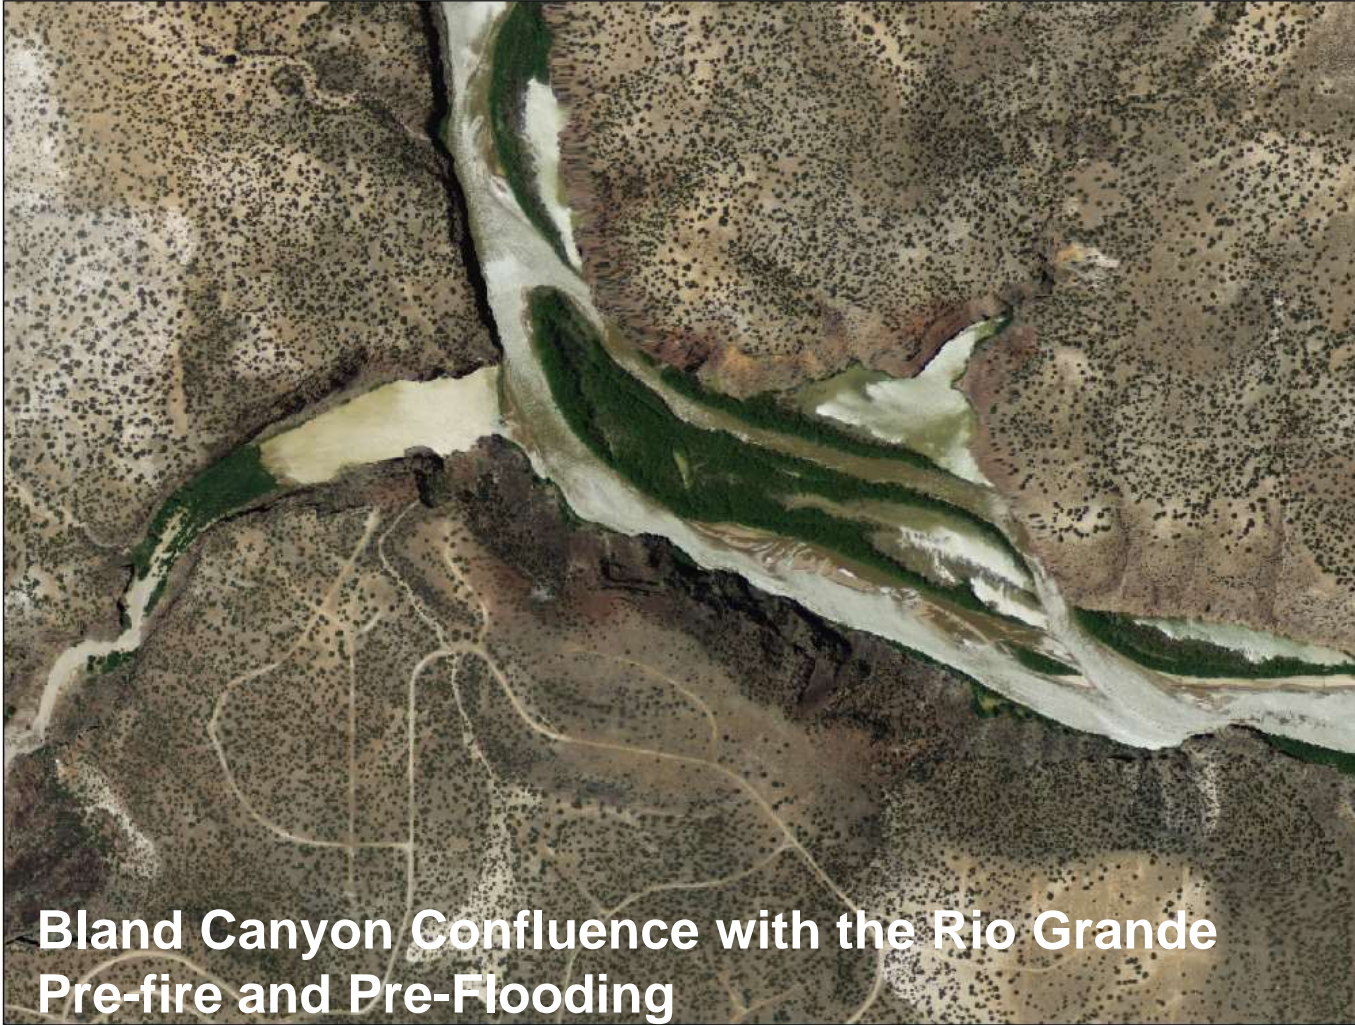
Bland Canyon Confluence with the Rio Grande  
Pre-fire and Pre-Flooding

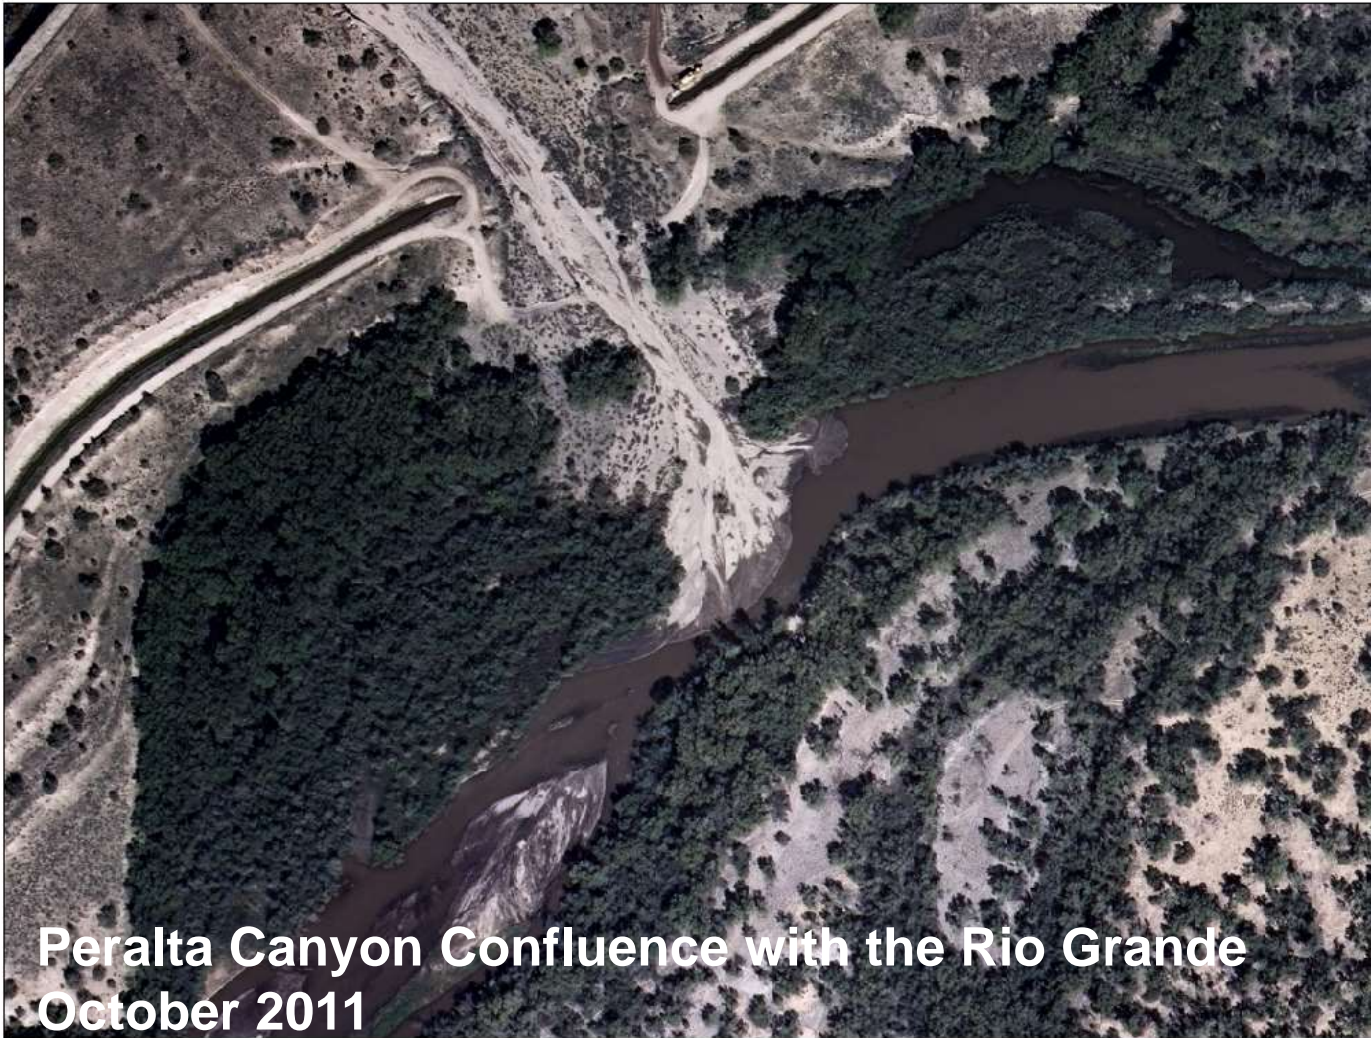
Peralta Canyon Confluence with the Rio Grande  
October 2011

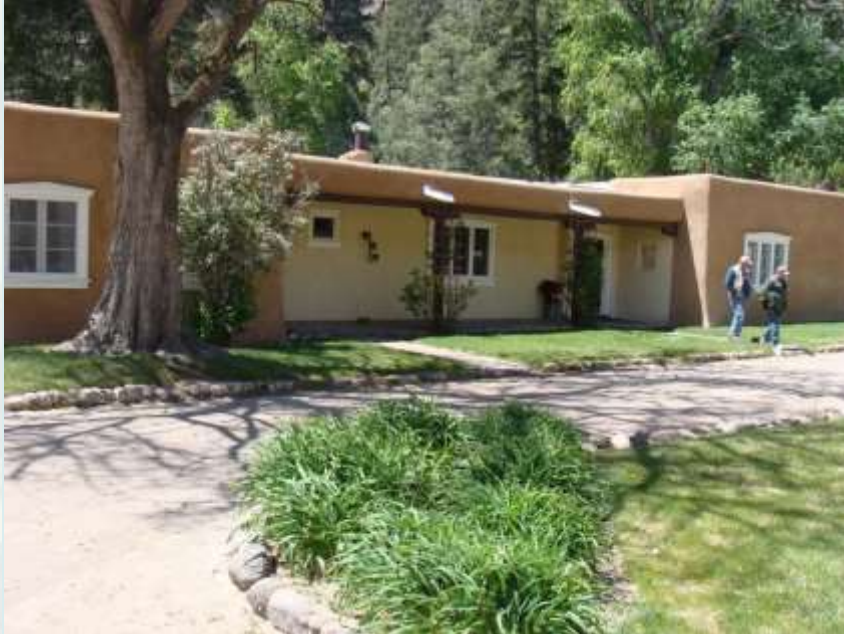
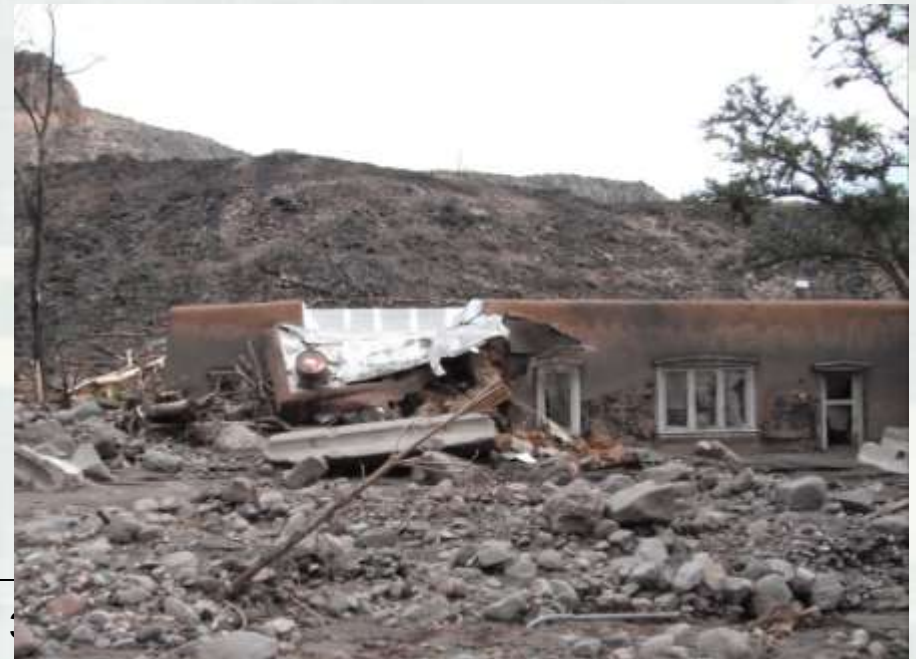
Dixon Conference Center  
Pre-Fire

Dixon Conference Center  
Post-Fire & Post-Flood
