# SHEAR BEHAVIOR OF URM RETROFITTED WITH FRP OVERLAYS

**ABSTRACT:** A large inventory of older masonry buildings exists in earthquake-prone regions. In most cases these buildings contain shear walls constructed of unreinforced masonry. The majority of these buildings were built before any provisions for earthquake loadings were established. The failures and damages reported in recent earthquakes attest to the need for efficient strengthening procedures. The effectiveness of increasing the shear strength of brick masonry by epoxy-bonding fiber-reinforced polymer (FRP) overlays to the exterior surfaces was evaluated. The variables in the test included the strength of the composite fabric, fiber orientation, and anchorage length. The specimens were tested under static loading. The results showed that both the strength and ductility of tested specimens were significantly enhanced with this technique. The orientation of the angle of fibers with respect to the plane of loading had a major effect on the stiffness of the retrofitted system but did not affect the ultimate strength significantly.

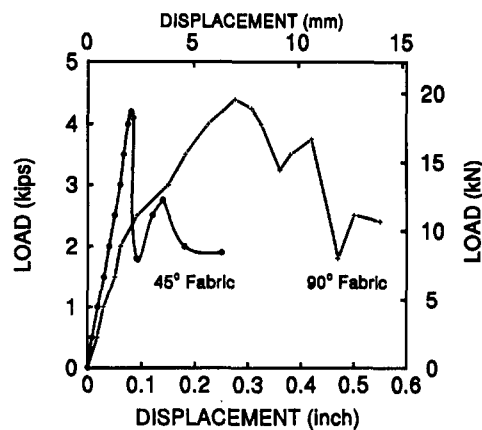
**FIG. 3. Typical Load versus Displacement Graph**

The description of test specimens is summarized in Table 2. Typical measured load versus displacement of the top of the middle brick for specimens with the fibers oriented at 45 and 90° are shown in Fig. 3. As can be seen several load peaks are presented in the descending portion of each graph. For clarity, it was decided to report each graph only up to the ultimate (peak) load value. The load versus displacement curves for 24 specimens that were considered for the analysis are presented in Figs. 4–6.

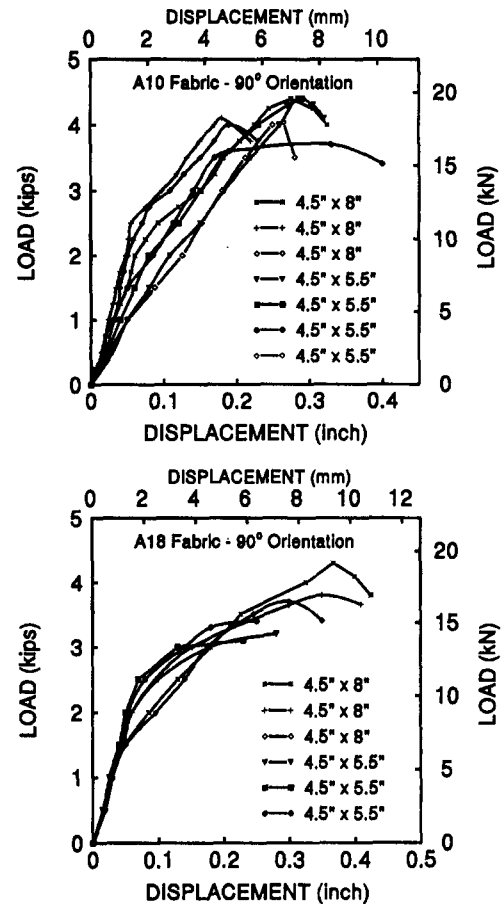
FIG. 6. Effect of Fabric Length on Ultimate Load

A shorter fabric, 14 × 11.5 mm (5.5 × 4.5 in.), was used to examine its influence on the strength. This length was used in A10-S-90 and A18-S-90 specimens. No specimens with short A12 fabrics were tested. As shown in Fig. 6(a), the ultimate load in the case of A10-S-90 and A10-L-90 specimens is almost the same for both fabric lengths. Also, it was observed during testing that the failure was due to a combination of delamination of the fabric at edges and shear failure at one of the joints. This indicates that the shorter length is sufficient to develop the full strength of the fabric. On the other hand, a difference in strength was observed in the case of A18-S-90 and A18-L-90 specimens as shown in Fig. 6(b). The failure of the specimens with shorter fabrics was due to delamination of fabric edges compared to delamination at the middle brick for specimens with long fabrics. The fabric failed in this manner since the fabric covered only 29 mm (1.12 in.) of the outer bricks from the joints while the longer fabric covered the full width of the outer bricks. This indicates the significance of anchorage (development) length in developing the full strength of the material.

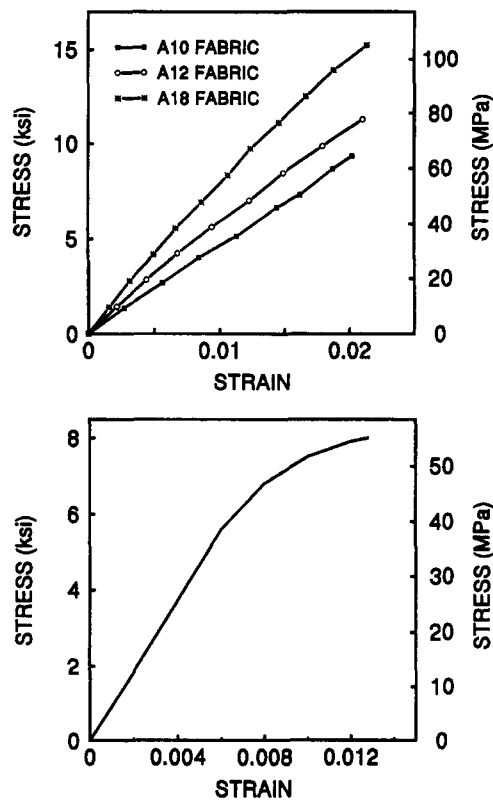
FIG. 8. Tensile and Shear Stress-Strain Relationship of GFRP Lamina

The behavior of composite laminates is highly dependent on the orientation of fibers and type of loading. Mallick (1988) reported that the tensile stress-strain relation for glass-fiber-composite laminate according to ASTM D3039 is almost linear up to failure. The same was confirmed for the various fiber densities used in this study as shown in Fig. 8(a). However, the shear stress-strain relation is nonlinear, as shown in Fig. 8(b) (Mallick 1988; Vinson and Sierakowski 1987). The same behavior was observed for fabric with 90° fiber orientation, as shown previously in the test results, where the fibers along the joints were stressed in shear. To understand the experimental results the stresses along the joints (failure plane) were analyzed using finite-element method (FEM) analysis and basic composite mechanics as discussed in the following sections.

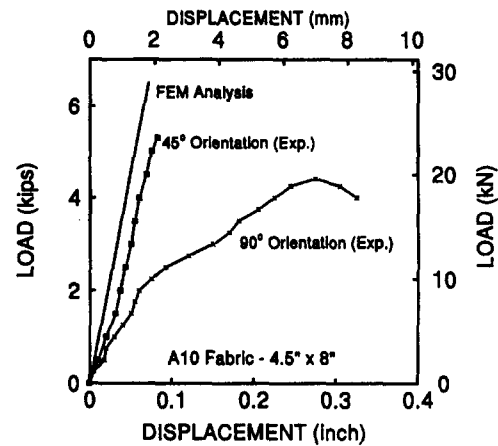
FIG. 13. Comparison of FEM and Experimental Results

The load versus displacement obtained from FEM is compared with the experimental results in Fig. 13. The predicted load versus displacement curve is compatible with the experimental results in the case of the 45° fiber orientation. The slight difference in the slope is attributed to the imperfect bond between the brick and the laminate in the test specimens; the FEM solution assumed perfect bond. The measured response is linear as was assumed in the analysis. There is clearly a difference between the FEM solution and the experimental results for specimens with 90° fabrics. It was shown that fibers oriented at 90° were stressed in shear, hence the response was expected to be nonlinear. Thus, the FEM model that assumes linear behavior for the FRP laminates is only valid for specimens with fibers oriented at 45°.
